INVESTIGATION OF THE CAUSES OF SILICON MOS — TRANSISTOR PARAMETERS CATASTROPHIC DEGRADATION

O. Kulinich, M. Glauberman, G. Chemeresuk, I. Yatsunsky

Mechnikov National University of Odessa (Training, Scientific-Investigation and
Production Center, Physical faculty), 4 Marshala Govorova st., Odessa 65063, Ukraine,
tel.: +380482 607252, fax: +380482 544491, e-mail: eltech@elaninet.com

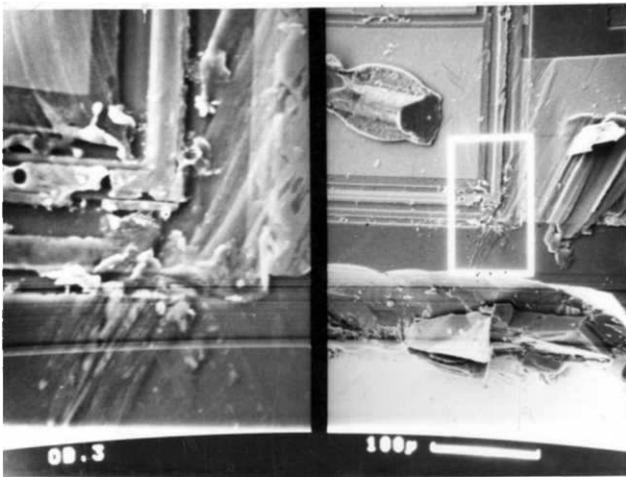
Figs. 1 (a,b) show the pictures of the disclosed latent defects, breaking of integrity of the metallized path to the gate, and mechanical damage of the pad for thermal compression, which come out after ionic etching for 25 minutes. Survey of this area in the reverse-biased electrons and absorbed current mode has shown that there are sections of lower conduction and break area. A micro-X-Ray spectrum analysis of the current conducting path has revealed the presence of both aluminum and molybdenum, and Al Si and Mo Si silicides in it.

Fig. 1,a Image of the metallization integrity breaking defect.

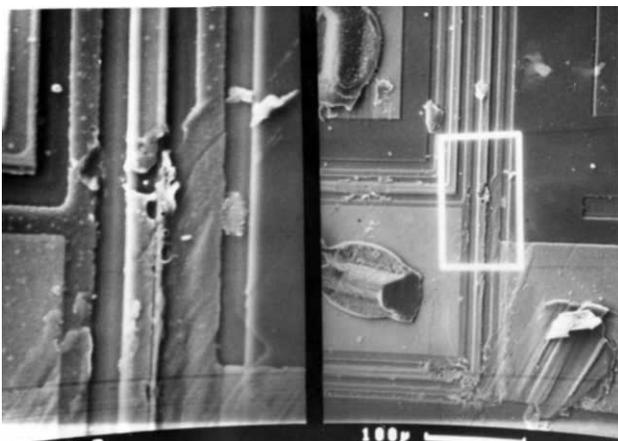
Fig. 1,b. Image of the metallization integrity breaking defect (photolayer etching).

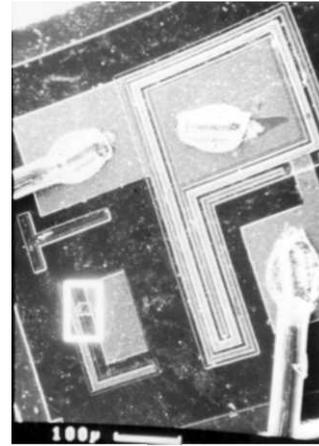
Intermetallic compounds of Al Au and Al Au Mo types have been found in the area of thermal compression contacts (Figs. 2).

Fig. 2. Image of the thermal compression contact break picture (general view).

The revealed intermetallic compounds led to brittleness and, as a consequence, to ruptures of the thermal compression gold-aluminum contacts.

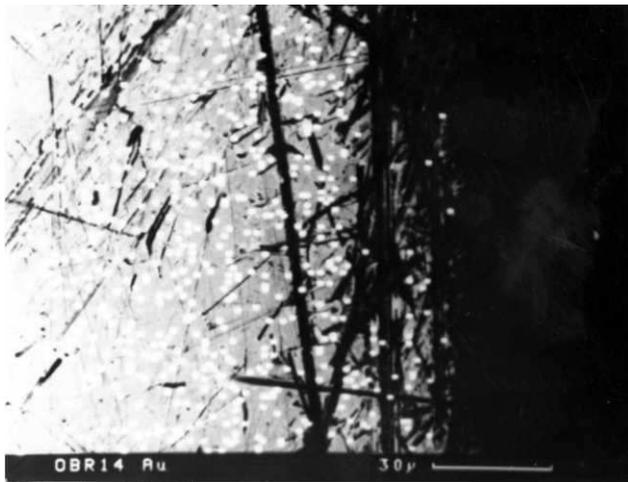
These compounds have a complex composition, depending on the conditions of their formation (gold and aluminum concentrations, temperature and pressure in the thermal compression process, free silicon presence, ambient temperature and service time of the ready MOS-transistor). Due to the difference in the lattice constants, formation of these compounds gives rise to mechanical stresses at the interface. It is well known that the yield point of crystalline substances depends on temperature [5]. The contacts are heated by the current flow, and as a consequence, in destruction of the contact. A detailed analysis of the failure mechanism has made it possible to find out, that interaction and interdiffusion of gold and aluminum occur in the process of thermal compression welding at the temperature of about 300° C, the diffusion rate of gold into aluminum being higher due to the higher value of gold diffusivity (Fig. 3). This diffusion causes formation at the Au-Al interface of intermetallic compounds, whose lattice constants parameters and thermal expansion coefficients differ from the similar lattice parameters of Au and Al, which gives rise to mechanical stresses. Metallization discontinuities have been found to be localized in areas of maximum dislocation clusters (Figs. 4) or lamellar nonuniformity defects clusters (Figs. 5), when the metallization is pickled off and the silicon

Fig. 3. Electronic image of the gold to aluminum diffusion process.

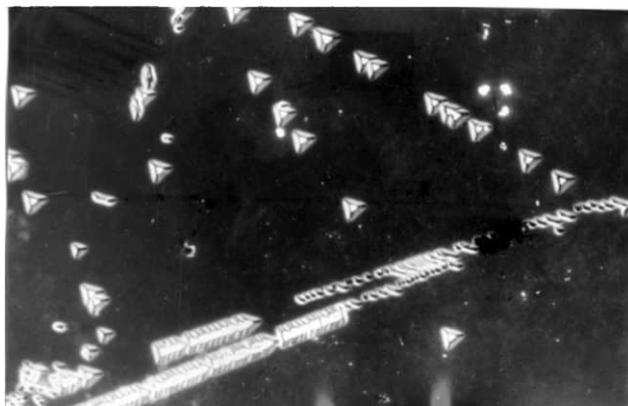
surface is treated with Secco (100) or Sirtl (111) [3,4] selective etchant. Despite the good metal-to-silicon adhesion, mechanical stresses arose in these areas, which caused destruction of the metal. Some cases of breaking the metallization uniformity could be associated with metal etching under a photoresist. The experiments have shown the metallization breaking to be largely dependent on the device formation technology.

Fig. 4. Electronic image of the dislocation cluster areas, revealed on the silicon surface after removal of the faulty metallization and treatment with the Secco selective etchant.

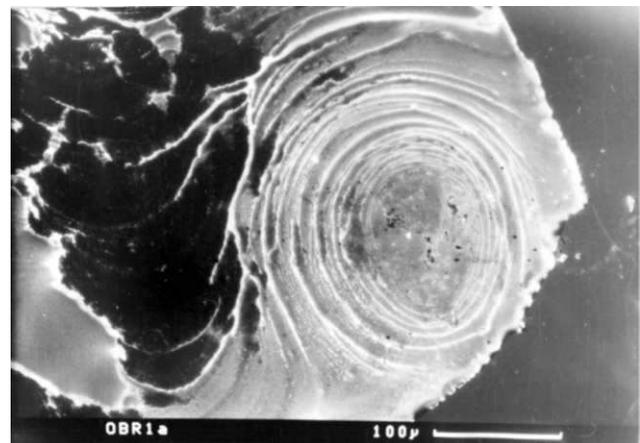
Fig. 5. Electronic image of the lamellar nonuniformity defect, revealed on the silicon surface after removal of the faulty metallization and treatment with the Secco selective etchant.
